Official Publication
NATIONAL ASSOCIATION OF CORROSION ENGINEERS

Vol. 14

MARCH, 1958

No. 3

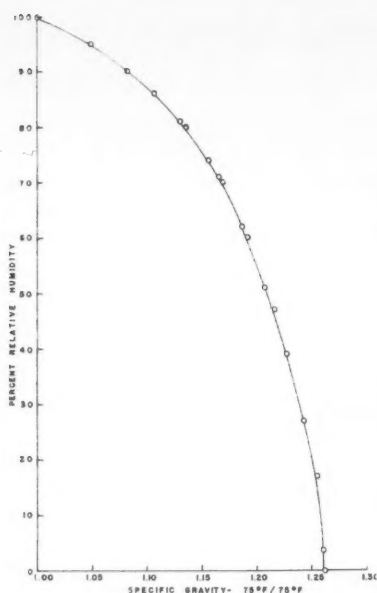
Figure 1—Relation between relative humidity over glycerol-water solutions and their specific gravities.

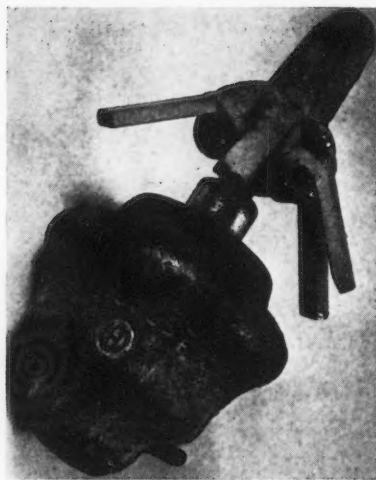
Figure 1—Insulator equipped with arcing horns.

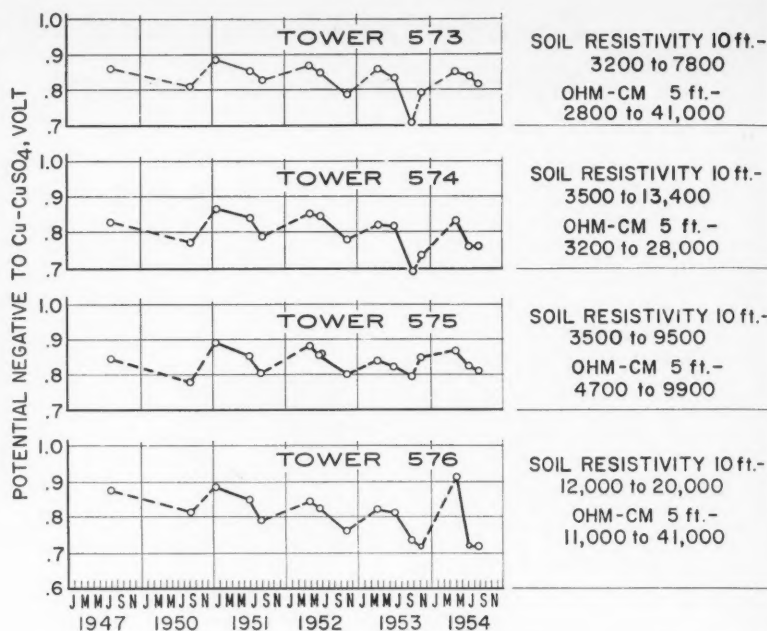
Figure 2—Potential changes of four towers representing old towers having medium low potentials.

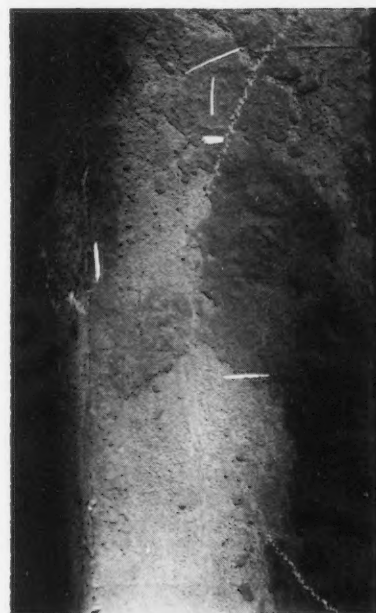
Figure 6—Fifty-mil deep pit in leg to Tower 2400.

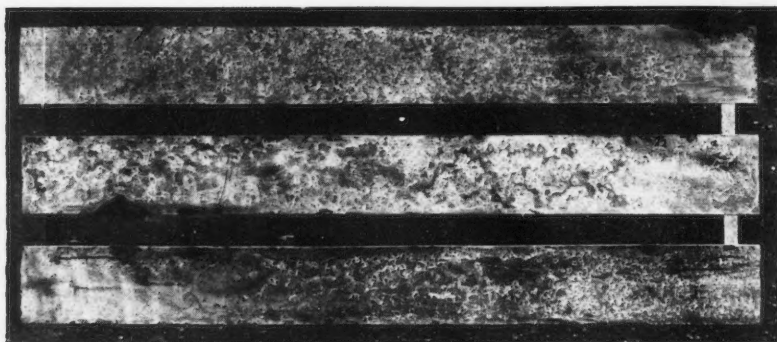
Figure 7—Corrosion on anchor of Tower 2400.

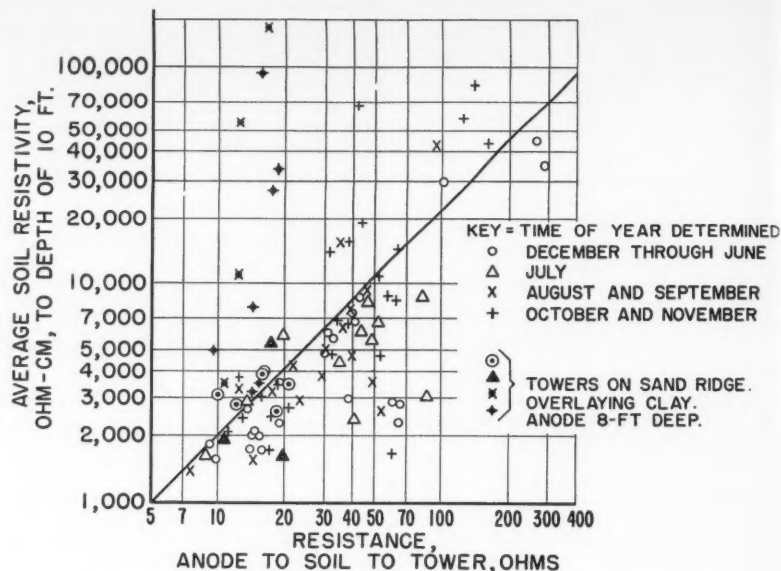
Figure 15—Effect of soil resistivity on current output of anodes attached to towers.

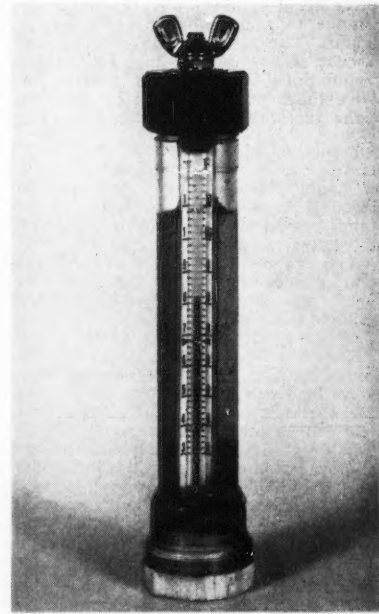
Figure 1—Copper sulfate electrode equipped with a darkroom thermometer.

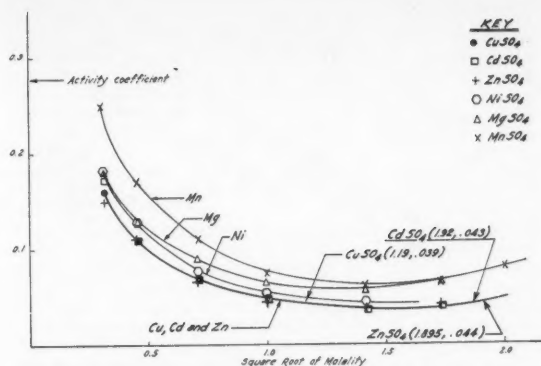
Figure 2—Activity coefficients of some bivalent metal surfaces.

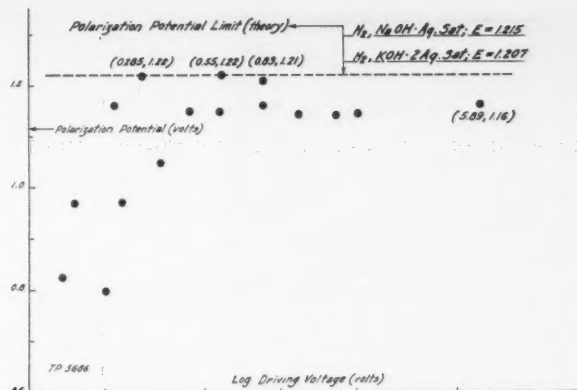
Figure 3—The polarization potential ceiling for pipe lines under cathodic protection.

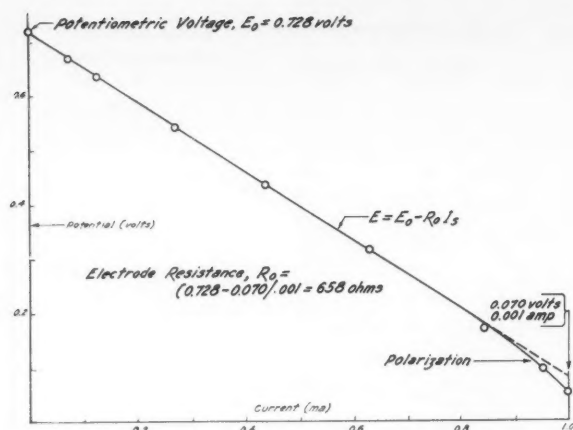
Figure 4—Polarization of the Miller copper sulfate electrode.

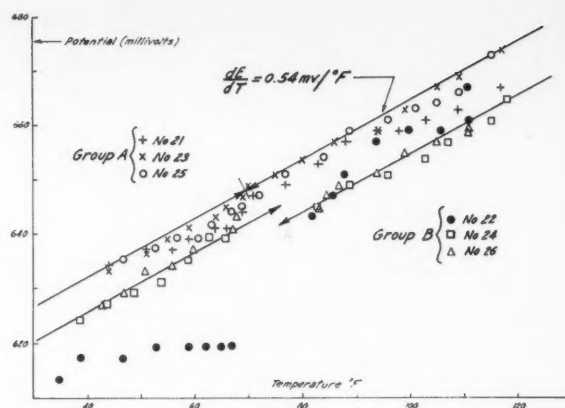
Figure 5—Temperature coefficient and hysteresis of the copper sulfate electrode.

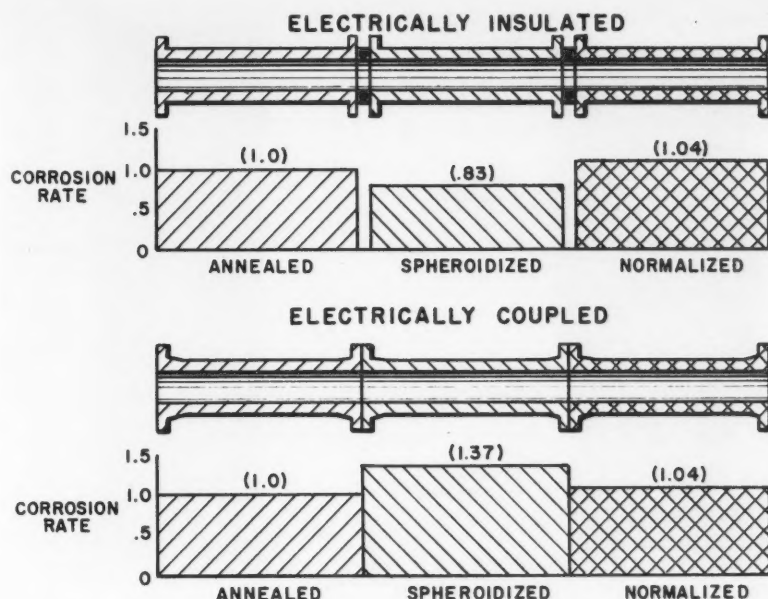
Figure 6—Corrosion rates in electrically insulated and electrically coupled pipe.

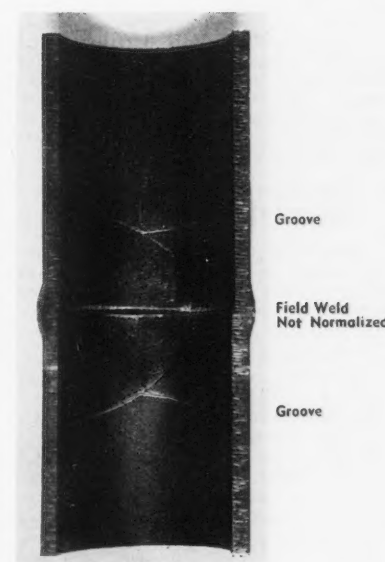
Figure 8—Two-inch schedule 80 test pipe in 65 percent sulfuric acid service. Temperature was 105 C (221 F).

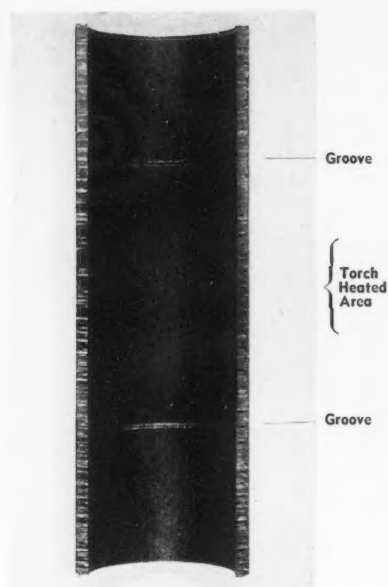
Figure 9—Test pipe in 65 percent sulfuric acid service. Pipe size was 1½-inch Schedule 80; temperature was 105 C (221 F).

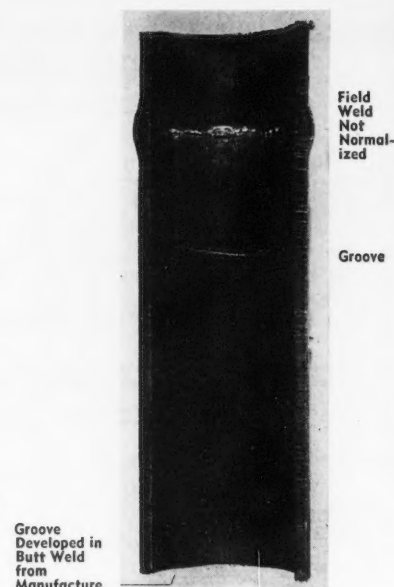
Figure 11—Test pipe in 65 percent sulfuric acid service. Pipe size was 1½-inch Schedule 80—butt welded; temperature was 105 C (221 F). Field Weld.

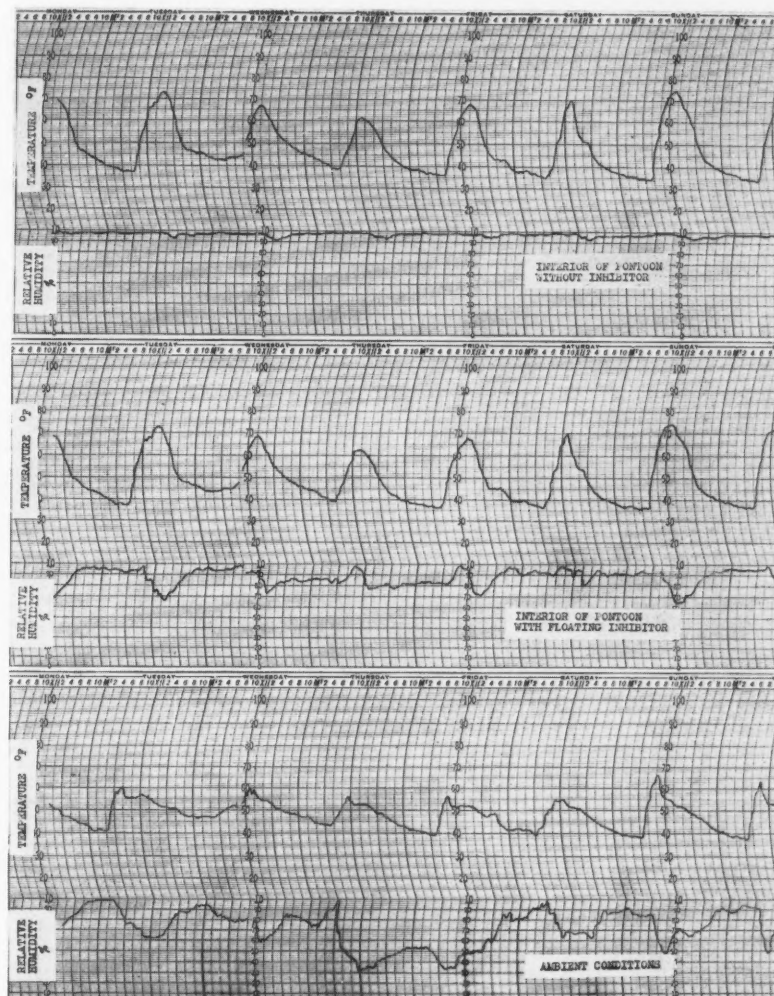
Figure 3—An illustration of the difference in the interior relative humidity of the test pontoons with and without floating inhibitor.

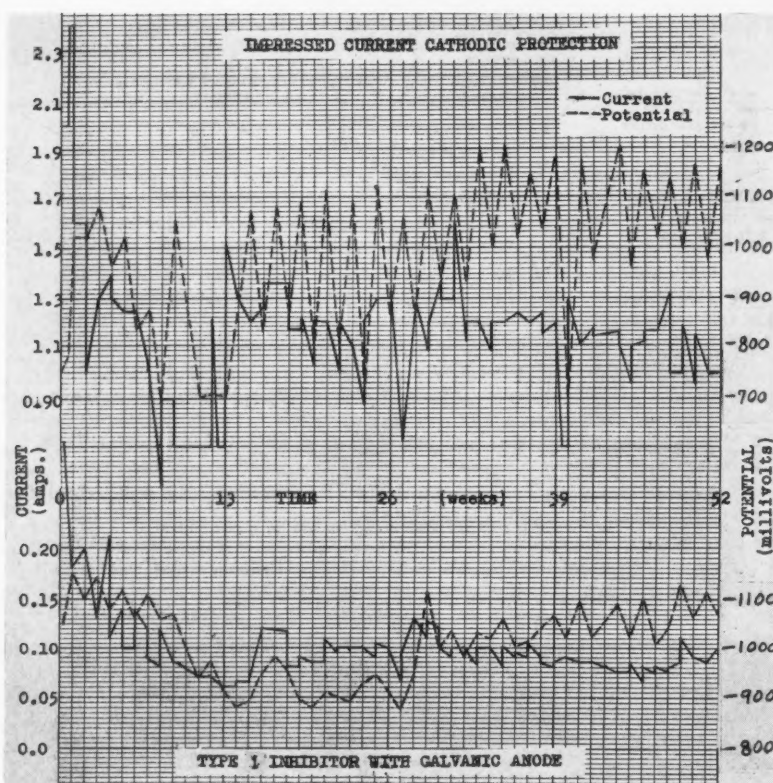
Figure 4—Potential and current data for impressed current cathodic protection and for Type 1 inhibitor with a galvanic anode.

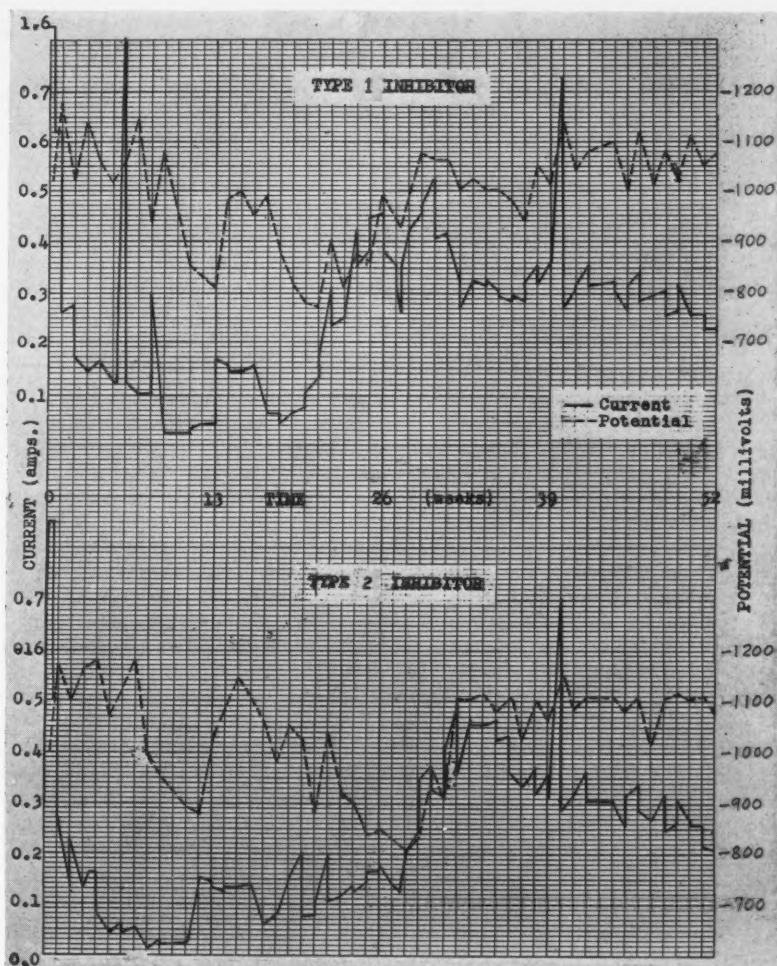
Figure 5—Potential and current data for Type 1 and Type 2 inhibitors with impressed cathodic protection current.

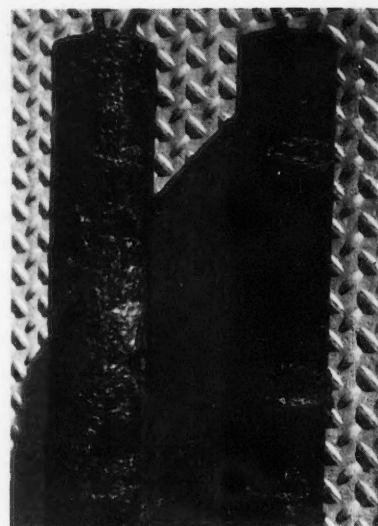
Figure 7—Graphite anodes used in conjunction with the floating inhibitors. The anode on the left is shown upon removal from the pontoon. The anode on the right was wiped clean to show deteriorated areas.

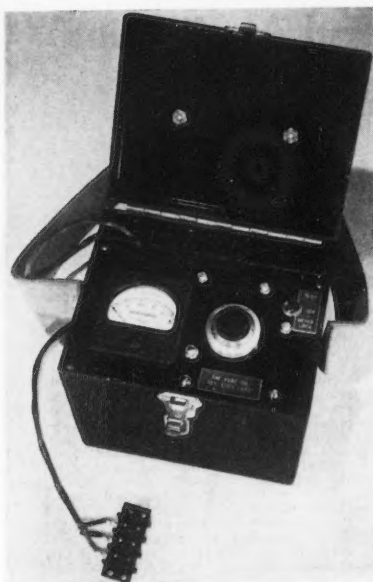
Figure 1—Portable corrosion meter.

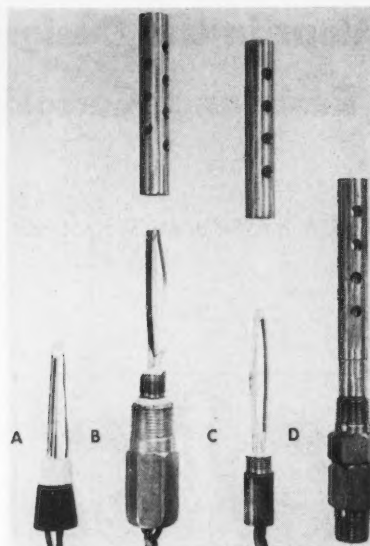
Figure 3—Typical corrosion test probes.

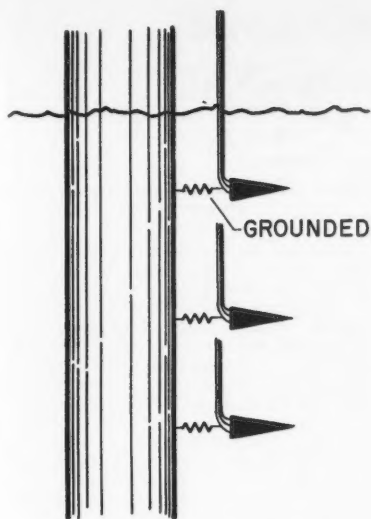
Figure 8—Testing of cathodic protection of marine structures.

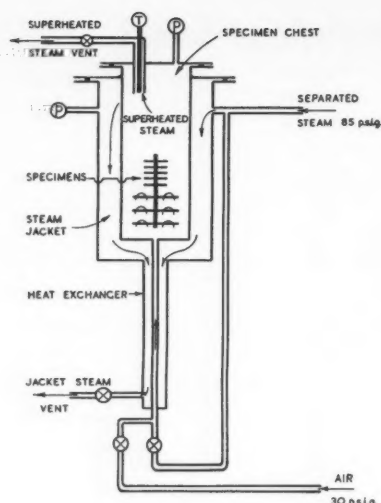
Figure 1—Diagrammatic arrangement of test equipment. Code to circled letters is as follows: P—pressure gauge; T—thermometer; X—valve.
